Tree Condition Survey
for
Great Bromley Parish Council

Date	5 th September 2021
Client	Great Bromley Parish Council
Report by	Mr James Choat BSc, M Arbor A
Site	Hare Green Rec, Church Meadow and Yard, St Georges Close
Reference No.	TPSar4730721

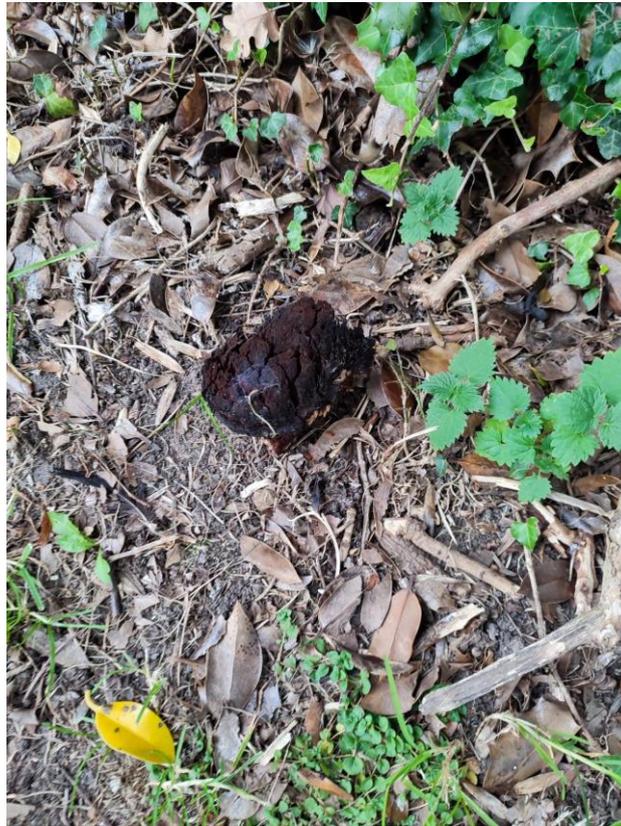
Photo1 Inonotus fungal bracket found on ground next to T7 Ash (Church Meadow Car Park)

1	T6	Red Oak <i>Quercus rubra</i>	EM	18	Low crown highway side. ECC highways recommend 5.2m crown clearance over highway.	Raise crown highway side to provide 5.2m crown clearance.	3	3
1	G1	Holly <i>Ilex Aquifolium</i>	M	8	Group of multi stem / suckers.	None	0	3
1	T7	Ash <i>Fraxinus excelsior</i>	M	19	Pronounced root flare with exposed surface roots. Recent crown reduction presumably due to crown decline, small amount still evident. Occasional tear wounds within crown. Occasional small diameter deadwood (less than 5cm in diameter) within crown. Old <i>Inonotus hispidus</i> fungal fruit body on ground, assumed to have fallen from T7 although location within crown was unable to be identified.	Monitor next autumn (early) - check for fungal fruit bodies and any further crown decline.	3	2
1	T8	Oak <i>Quercus robur</i>	Y	7	Young / recent planting.	None	0	3
1	T9	Oak <i>Quercus robur</i>	M	18	Appears to be 2 different species of <i>Ganoderma sp</i> at 3 locations around base - <i>Applanatum</i> and <i>Resinaecium</i> . Tapped with mallet around base and up to 1m above location of fungal fruit bodies - no hollowing sound observed - likely recent, 3 years growth at one location.	Option 1 - Carry out PICUS examination (internal electronic decay mapping) to determine extent of decay. Option 2 - Reduce crown by 2-3m to reduce crown sail area. Option 3 Fell and replace. Option 1 and 2 will require ongoing monitoring of the tree if retained.	3	2

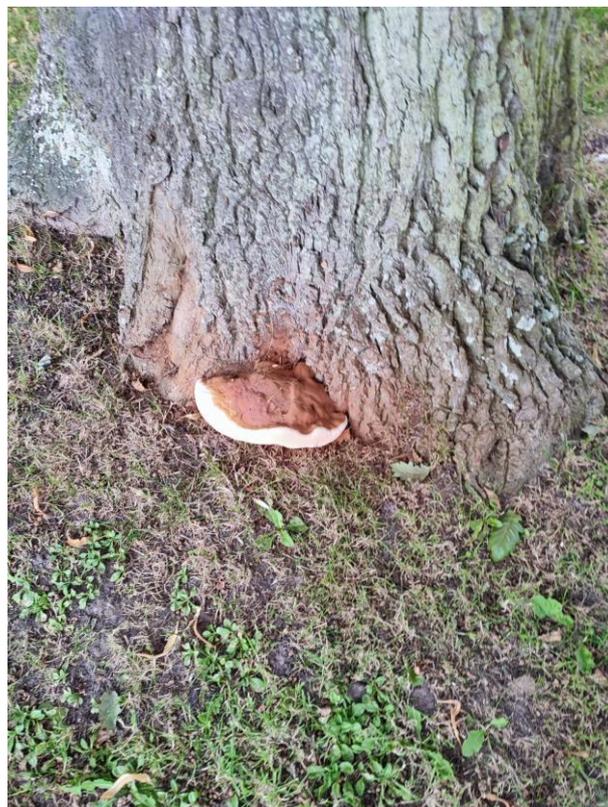
Photo 2 Ganoderma found on T9 Oak (Church Meadow Car Park)

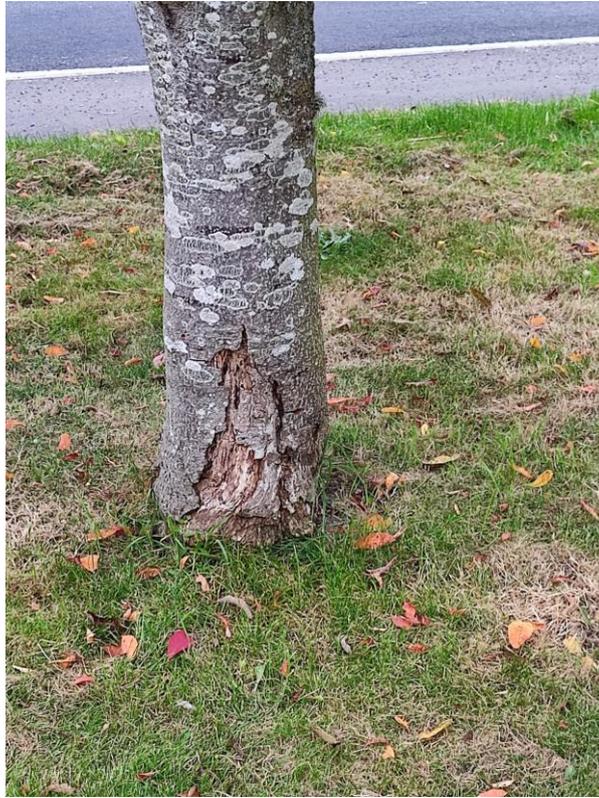
The site is approximately 0.13 Ha in size . The site contains a wide verge / open space situated to the frontage of a small collection of housing within a cul-de-sac location. The site contains mown, improved grass and occasional amenity trees, there are no built structures on the site and no open space furniture (benches, seating, bins etc). The ‘B’ road highway (B1029) runs to the west of the site. The site contains a collection of mostly early mature trees with few obvious defects noted. T17 Birch cherry is in decline and has root collar decay, suggestive of honey fungus.

Photo 3 T17 Root collar decay (St Georges Close)

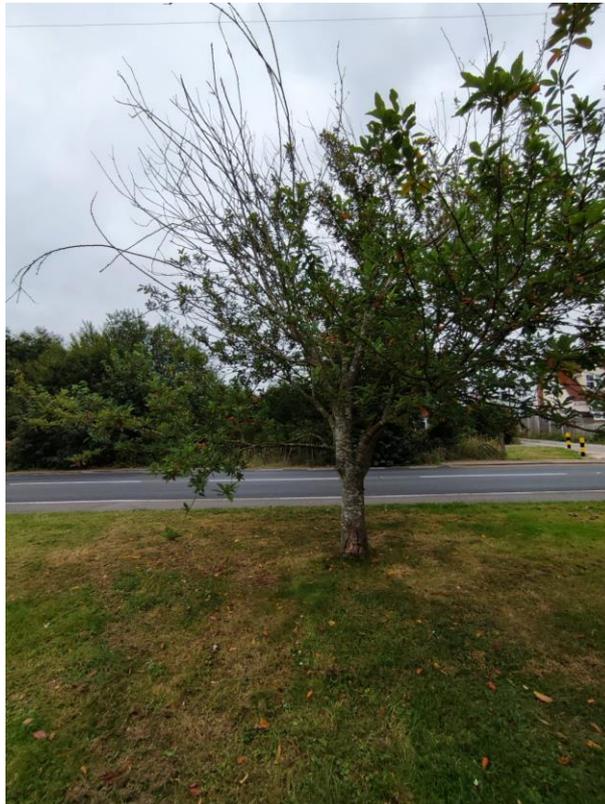
Photo 4 T17 Crown decline (St Georges Close)

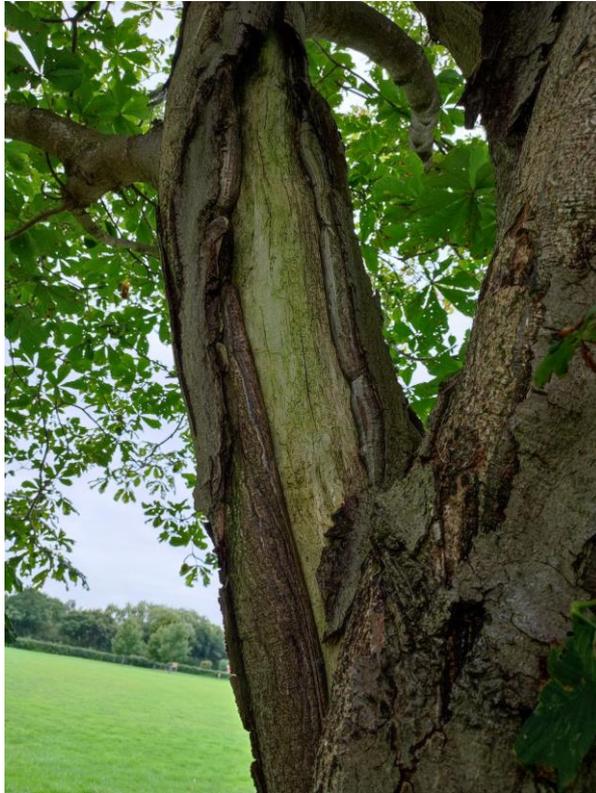
The site is approximately 1.5 Ha in size . The site contains a children’s play area, open space furniture (benches, seating, bins etc) and mown, improved grass used for passive recreation. No parking facility is provided and there are no built structures on site. A surfaced footpath runs from south to north diagonally through the site. Generally the condition of the trees is reasonable, with mostly routine works such as crown lift management and deadwood removal, tree T34 is in poor condition and is recommended to be felled.

Photo 5 T34 Bleeding canker disease (Hare Green)

3	T28	Ash <i>Fraxinus excelsior</i>	Y	4	Previously reduced / coppiced resulting in multi stem, and poor crown shape / condition.	Consider felling although low risk.	3	3
3	T29	Bird cherry <i>Prunus padus</i>	Y	7	Good condition. Low crown.	Raise crown to 2.5m.	3	3
3	T30	Oak <i>Quercus robur</i>	EM	15	Rooted in hedgerow, unable to assess base. Crown and leaves appeared healthy.	None	0	3
3	T31	Oak <i>Quercus robur</i>	Y	8	Rooted in hedgerow, unable to assess base. Crown and leaves appeared healthy.	None	0	3
3	T32	Silver birch <i>Betula pendula</i>	M	17	Low crown. Tensile fork at 1.5m Small tear wound at 1.2m probed to around 10-15cm in to stem.	Raise crown to 4m removing sub-laterals only.	3	3
3	T33	Oak <i>Quercus robur</i>	Y	8	Rooted in hedgerow, unable to assess base. Crown and leaves appeared healthy.	None	0	3
3	T34	Horse Chestnut <i>Aesculus hippocastanum</i>	EM	15	Bleeding canker disease affecting 2 main scaffold branches, significant girdling on southern and central stem, open wounds with sapwood exposed. Previous branch failure from southern most stem. Guignardia and leaf miner affecting leaves.	Fell and grind stump.	2	0

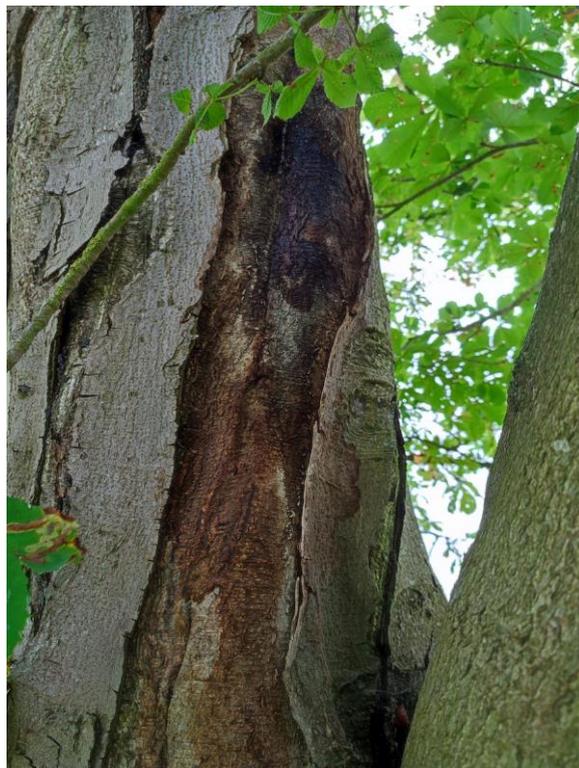
Photo 6 T34 Bleeding canker disease (Hare Green Rec)
